CHIRP FEEDBACK

Issue No: 15

2/2007

A Maritime Safety Newsletter

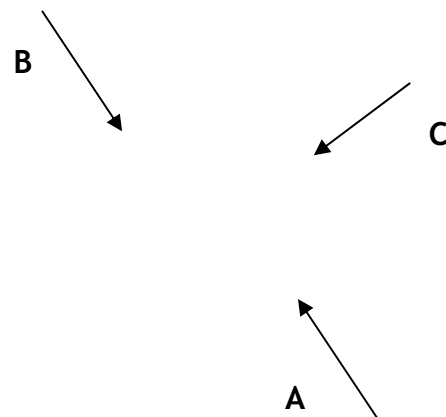
Vessel (C) Course: 225 (T) in TSS

Vessel speed: Approx. 16,5 knots

It was noted that a ferry (A) was crossing the channel at right angles to the flow of traffic. It was noted that this vessel would have a CPA of 0' initially and that the speed of this vessel was initially approximately 16.5 knots. This vessel was on my port bow and thus I was the "stand on" vessel. Initial distance of this vessel approximately 5.5 miles

Simultaneously, it was noted that another ferry (B) was transiting in the opposite direction to (A). This vessel also had a CPA of 0' and as she was on my starboard bow, I was obliged to keep out of her way.

The situation was monitored closely and it became apparent that the initial actions of vessel (A) were insufficient to avoid a close quarter situation with own vessel. I attempted to contact vessel (A), via VHF Channel 16. My calls elicited nil response despite my repeating the call on a number of occasions and using all methods to identify myself.

It was then noted that (A) increased her speed as a method of avoiding a close quarter situation and would pass ahead of us at a distance of approximately one mile. However, I was still having a 0' CPA with the (B) who, quite correctly, maintained her course and speed throughout. I attempted further contact via VHF channel 16 with (A) but once again without response. I wanted to alert the O.O.W. on that vessel that his/her actions were causing me grave embarrassment with (B) and that as a result of the choice to increase speed, I was unable to alter course, as would be required, to avoid (B).

Once it was apparent that a potential 'close quarter' situation was developing, I engaged hand steering and when (A) was observed ahead of my vessel, I altered my course to starboard by an eventual 25 degrees enabling the (B) to pass ahead of me safely.

- **The passing distances involved are not unusual for this busy area and ferry bridge teams are likely to be accustomed to them, however, they should be aware that other vessels, who transit less frequently, may be concerned by their proximity and should take measures to make their intentions clear.**
- **Whilst VHF use may be appropriate on occasion, the time used by vessel (C) trying to establish contact by VHF may have been used more effectively in assessing and reacting to the situation. Subsequent investigations indicated (C) may not have been transmitting in any event.**
- **A prompt alteration of course or reduction in speed by vessel (C) may have been the best solution and would have required ferry (A) to reassess its own actions.**
